# Manhole Inspection Summary

Manhole # S49I\_\_021MH

Insp Date: **4/1/08 9:14 AM**

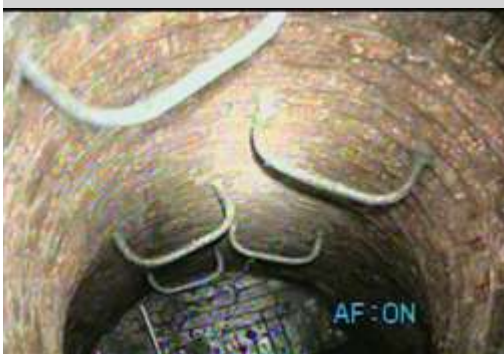
Defect 2

☒ **Corroded**

corroded stairs

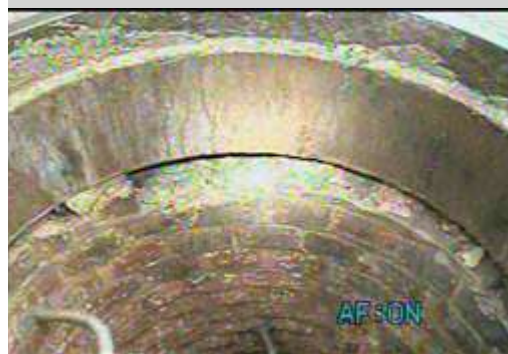
Defect 1

Condition: ☐ Sound ☐ Cracked ☐ Root Intrusion ☒ **Loose Brick** ☐ Deteriorated

loose brick in chimney

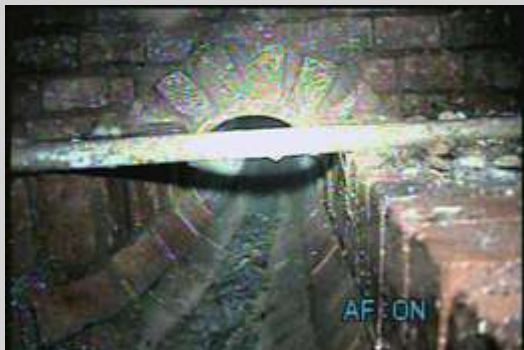
12 O'Clock Outflow

8 in. Circular Gravity Sewer  
Pipe Out @ 12 O'Clock

Deposits: ☒ None ☐ Mud ☐ Sludge ☐ Debris ☐ Grease

Infiltration: **None** Pipe Seal Cond: **Unknown**

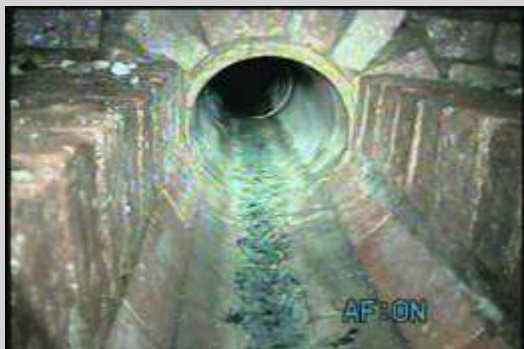
6 O'Clock Inflow

8 in. Circular Gravity Sewer  
Pipe In @ 6 O'Clock

Deposits: ☒ None ☐ Mud ☐ Sludge ☐ Debris ☐ Grease

Infiltration: **None** Pipe Seal Cond: **Unknown**

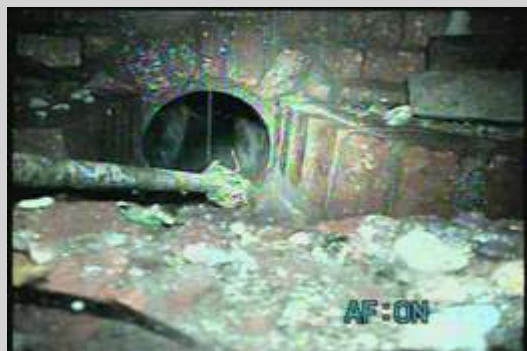
9 O'Clock Inflow

8 in. Circular Gravity Sewer  
Pipe In @ 9 O'Clock

Deposits: ☒ None ☐ Mud ☐ Sludge ☐ Debris ☐ Grease

Infiltration: **None** Pipe Seal Cond: **Unknown**
